# **Montgomery County Fire and Rescue Service**

## **POST INCIDENT ANALYSIS**

### **Confined Space Rescue 1220 East-West Highway Silver Spring, MD**

**Incident Date: January 17, 2012**

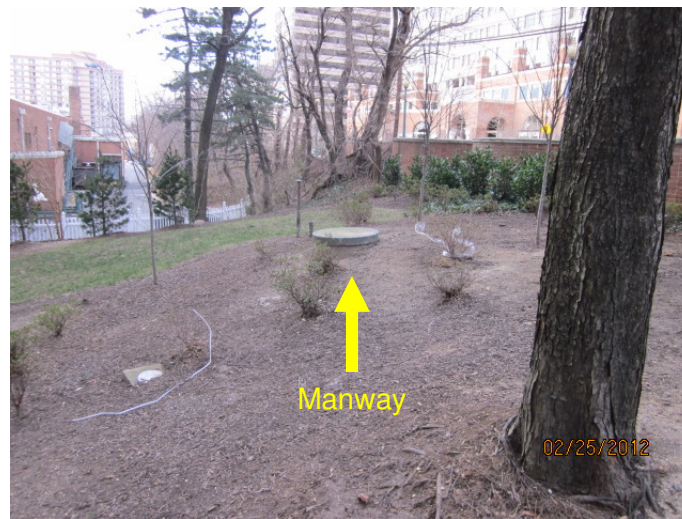
*Tank Entry - Side Alpha of 1220 East West Highway*

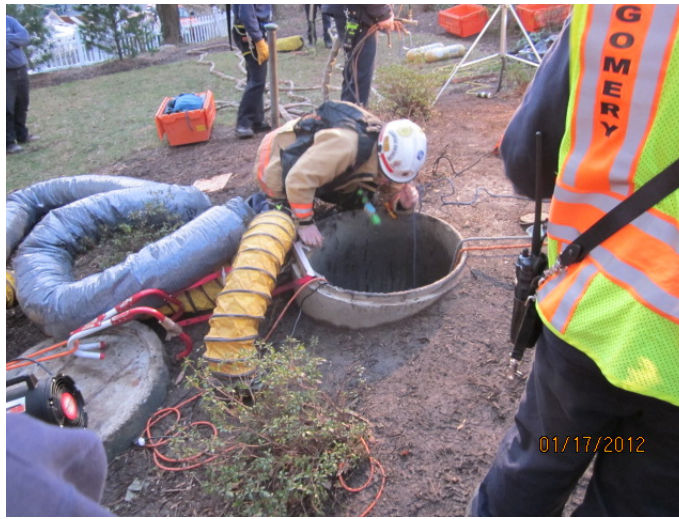
*Making contact with the victim.*

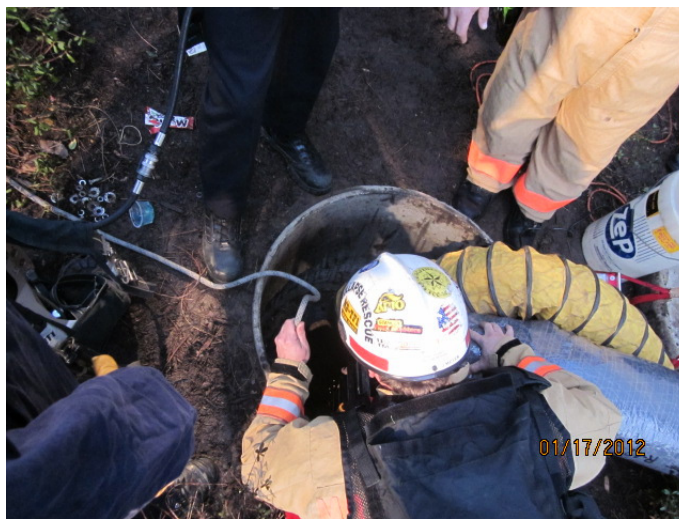
*Metering and ventilating the space.*

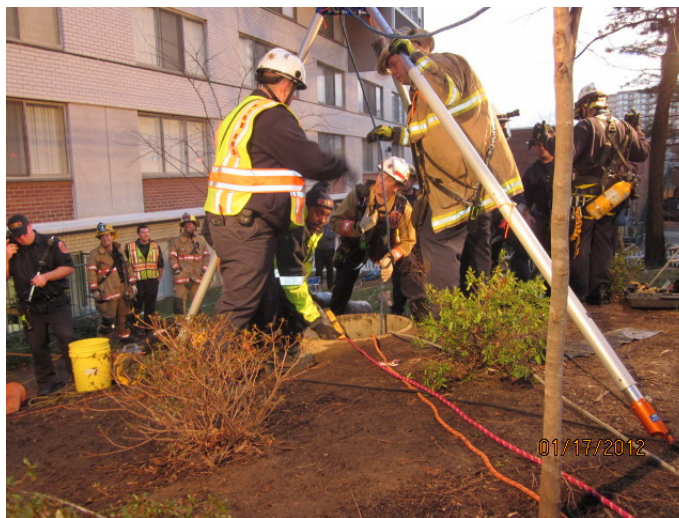
*The retrieval system.*

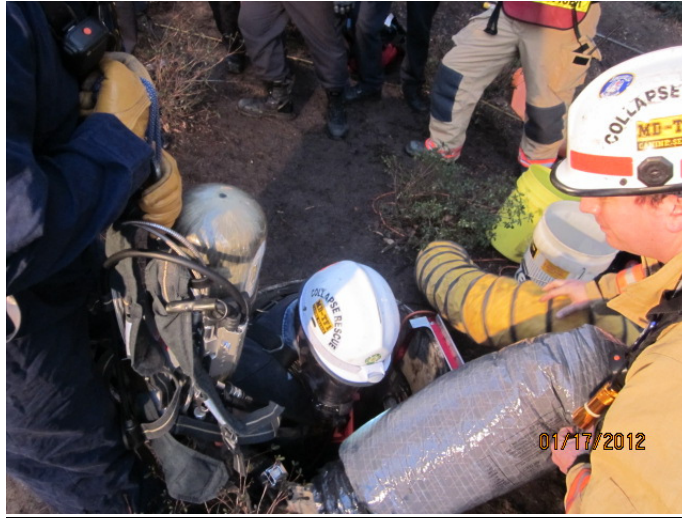
*Making entry.*

- The Entry Team used 60-min SCBA from HM707. While this choice of SCBA certainly provided a longer duration air supply, the 60-min SCBA had a larger profile than a 45-min SCBA. However, at this incident, the narrowness of the tank manway required any entry team member to remove his SCBA in order to pass through the opening.

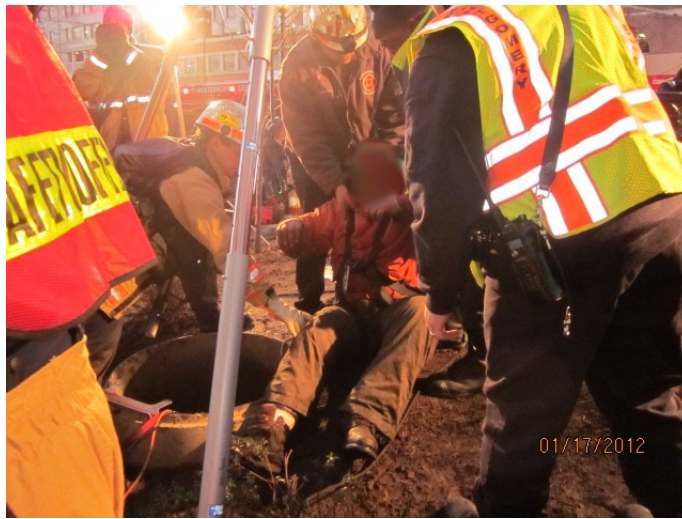
*Victim removal.*
